Swift Currents Keep Eel Pond's Navigation Channel Open

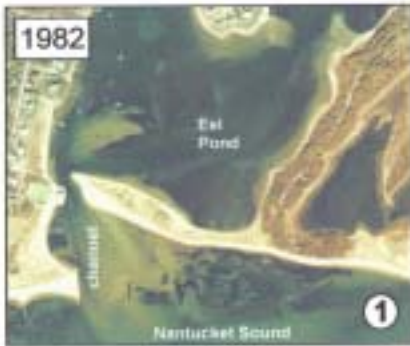
Prior to Hurricane Bob in August 1992 there was one opening connecting Eel Pond to Nantucket Sound (#1). It was a narrow, deep channel (#3), kept that way by periodic dredging. Actually, the need for dredging was much reduced by maintaining its deep, narrow shape. Tidal flows through the cut were swift enough to scour away sand that might get deposited there by wave action. However, as tidal flows leave the breach area, they are no longer constrained by its confines. They fan out across the flats, slowing markedly. Sand that was carried by the tidal flows through the cut drops from the slowing water to the bottom, making the flats even more shallow. It is there that frequent dredging is required to maintain navigation access to Eel Pond.

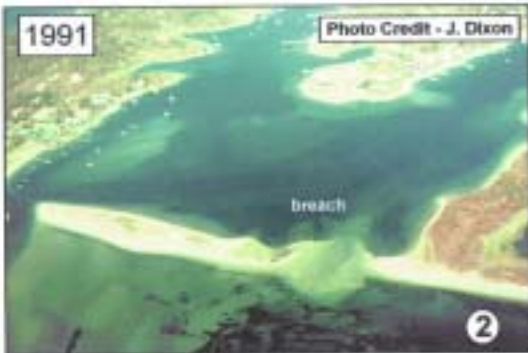
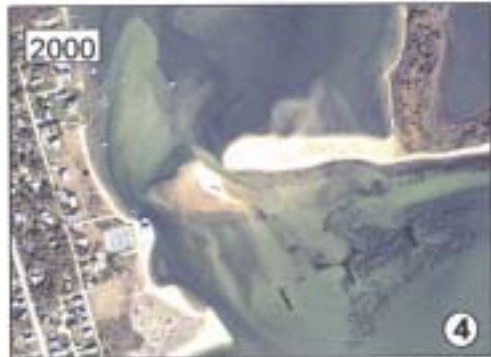
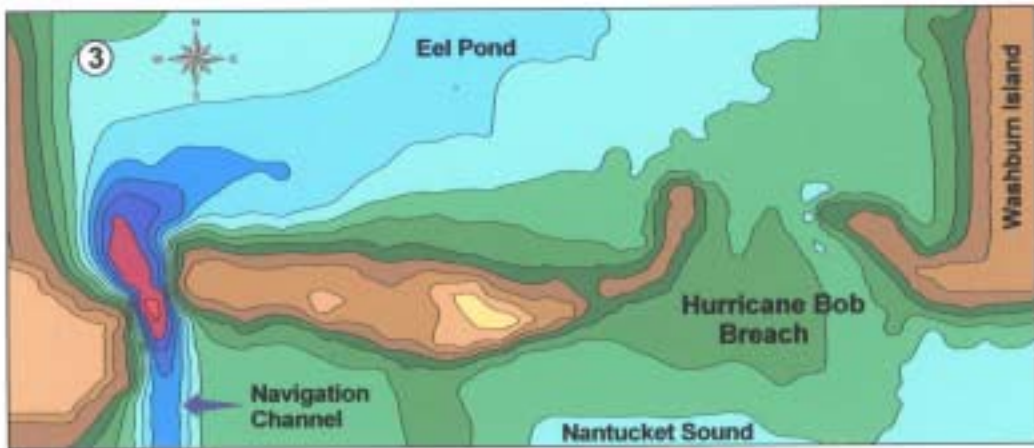
In contrast, the breach opened by Hurricane Bob was wide and shallow (#2, #3). Never dredged, its tidal flows were slow, insufficient to keep it clear. Sand was deposited in the opening, causing it to change shape as it migrated slowly to the west (#3). By 2000, 8 years after the storm, the breach was nearly gone (#4). In the summer of 2003, only the deep, narrow navigation channel remained.

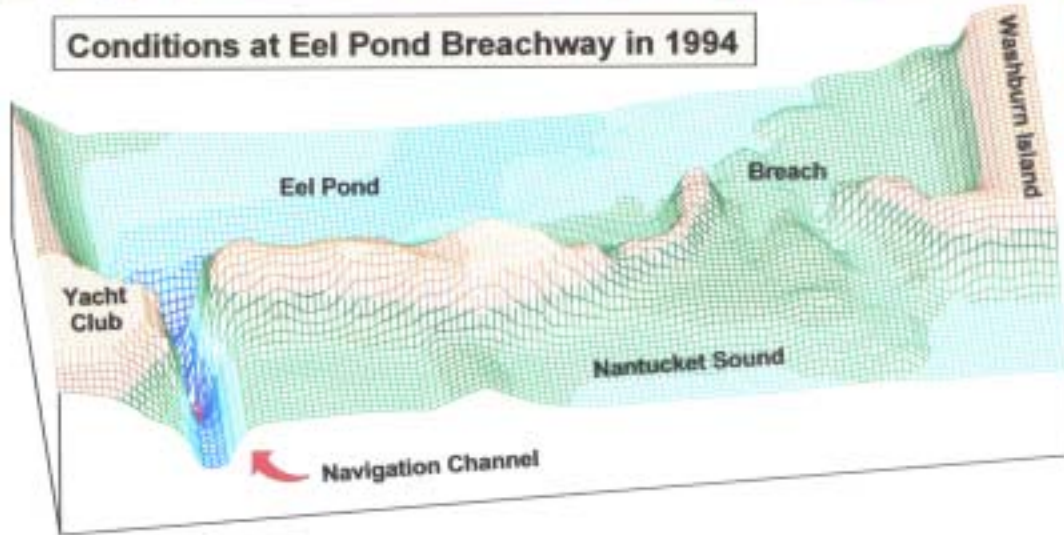
Conditions at Eel Pond Breachway in 1994
