The Story of Eel Pond Beach and its Breachway

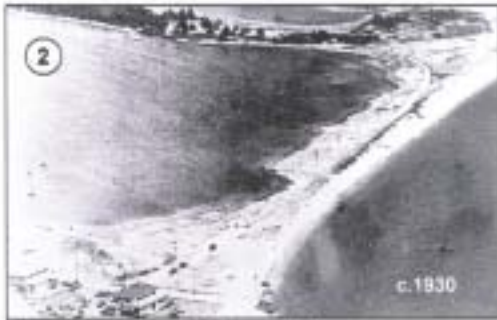
In 1846 (#1), the beach was broad and expansive. Wagons travelled across the beach to the farms and houses on the peninsula. However, over the years erosion carried away sand and the beach narrowed considerably (#2). By the 1930s, the beach was so low and narrow that the road was on a causeway built on wooden pilings. A hurricane in 1938 washed away the causeway and opened the first breach (#3) but authorities quickly filled it.

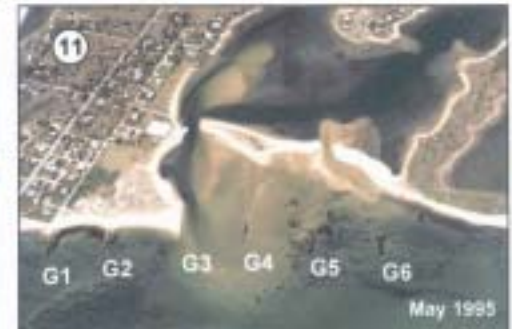
When the Army opened a training base on the peninsula in 1942, they added sand to the beach, along with rock groins (G1 - G6) and a new road (#4). (Note that the 1938 opening was between G2 and G3.) A hurricane in 1944 completely washed out the beach, destroyed the road and moved the back of the beach well northward. The peninsula, cut off from Menauhant since then, was renamed Washburn Island. By 1947 (#5), one opening through the beach remained (between G3 and G4) and was dredged for navigation to the bay.

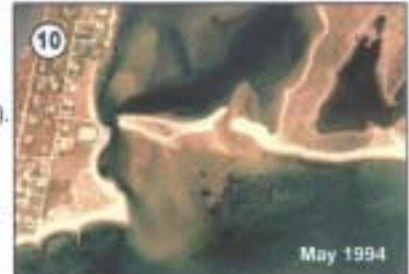
Erosion by currents and waves has continuously reworked the beach. As it moved northward (#6, #7 #8), some of the groins (G4 - G6) became stranded offshore as small rocky islands to be avoided by sailors. In 1991, Hurricane Bob created a new breachway (#9), cutting off the beach altogether and creating "Gull Island". Erosion continued to change the shape of the land. The new breachway slowly moved westward (#10, #11), shrinking Gull Island in the process. By 2000 (#12), all that remained of it was a small patch of sand. A little more than a year later, Gull Island had reattached and once again there was only one breachway. During it all, periodic dredging has kept the main channel, open since 1944, deep enough for boats to enter Eel Pond, Childs River, and Waquoit Bay.
